**Preliminary
Report of Findings
Hurricane Harvey Damage**

**Cole & Ashcroft, LP
5631 Brystone Drive
Houston, Texas 77041**

***Project No.: 11992
Date: November 8, 2019
Texas Engineering Firm No. F-11857***

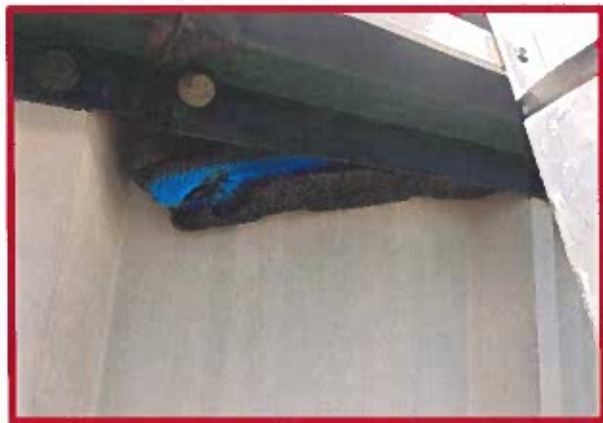
Photograph 26

On the office roof, we observed sealant was applied to all screws. Rubber gaskets pulled off head-wall flashing at taller building wall. There were hail dents and crimps on some roofing panels. Panels were separated at the longitudinal overlap panel joints. Screws were partially separated at overlap panel joints. The following photographs show samples of roof damage.

Photograph 26: Office Roof - Wind displaced closure strip

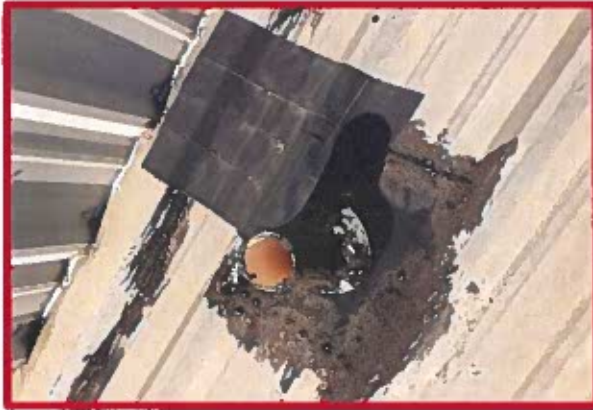
Photograph 17

Photograph 17: Office Roof - Loose screw
Sealant applied to vent roof jack

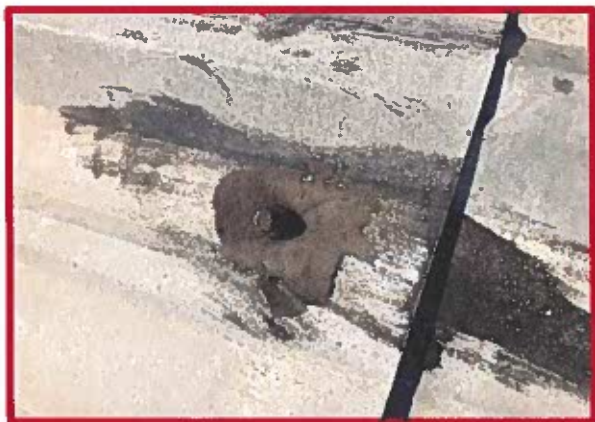
Photograph 39

On the warehouse roof sealant had been applied to the screws. We observed wind bent gutter support brackets, crimped panel seams and hail dents on the roof panels. Panels were separated at the longitudinal overlap panel joints. Screws were partially separated at side joints. There were dents on the metal panel at screws indicating wind lift at on the roof panels. We also observed wind lifted side joints.

Photograph 39: Warehouse Roof - Wind lifted side joint

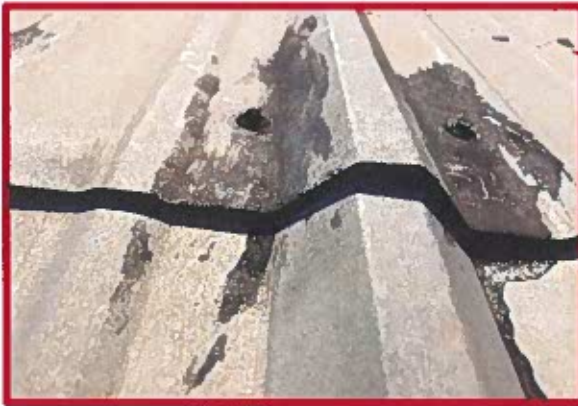
Photograph 61

Photograph 61: Roof - Screw with dented metal; separated longitudinal joint; dent on roof panel at screw

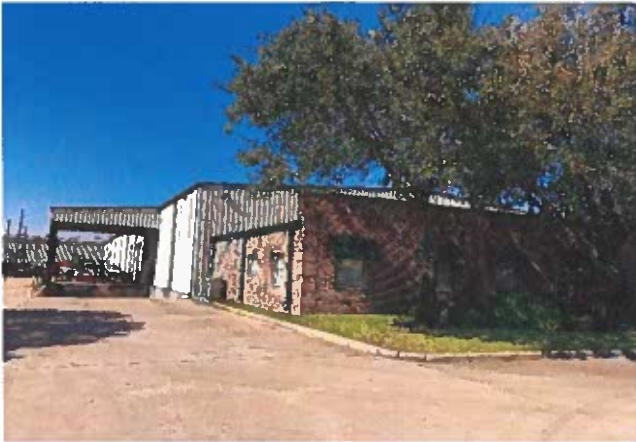
Photograph 1: Front - Overall view with left side

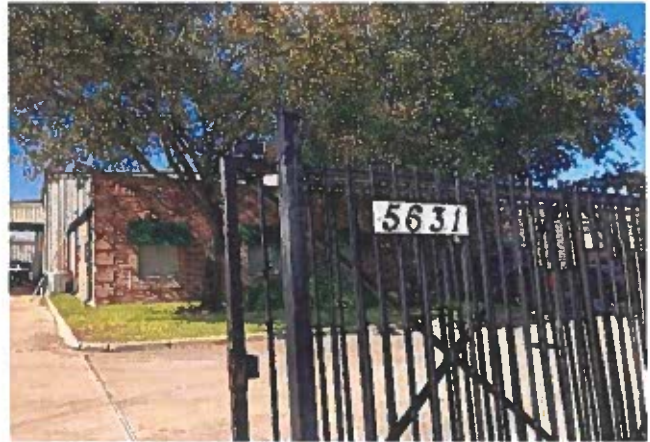
Photograph 2: Front - Address street number

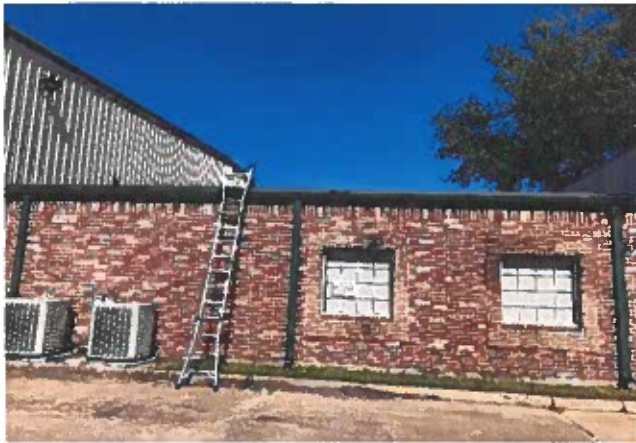
Photograph 3: Left Side - Overall view at Office

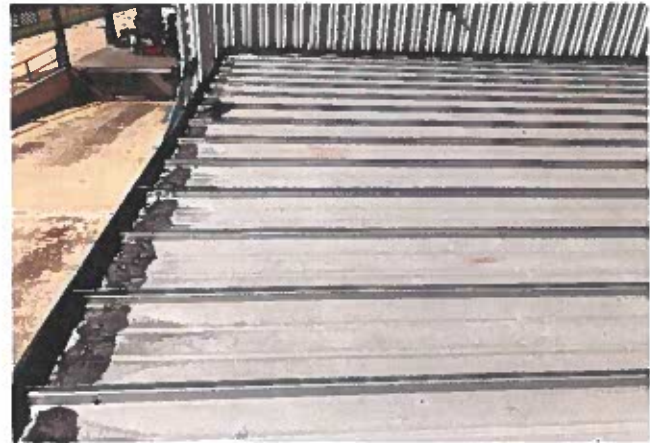
Photograph 4: Office Roof - Left side edge; screws covered with sealant

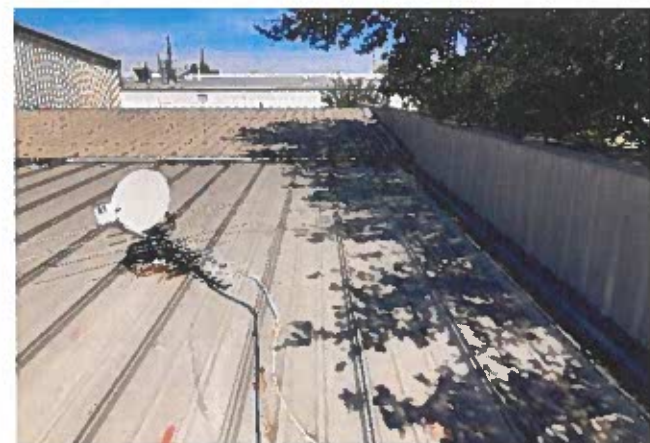
Photograph 6: Office Roof - Left slope; dirt and debris at gutter end

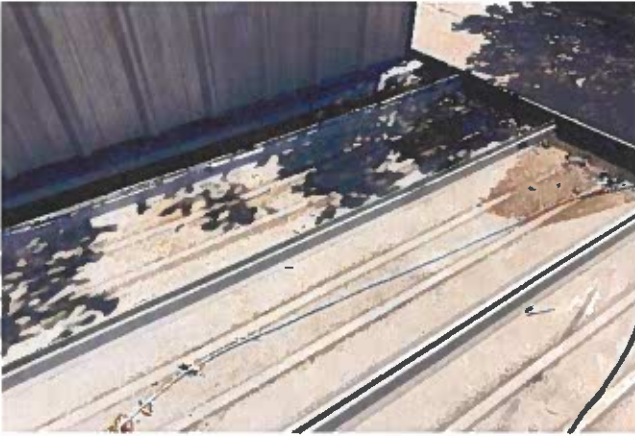
Photograph 7: Office Roof - Right corner at rear building

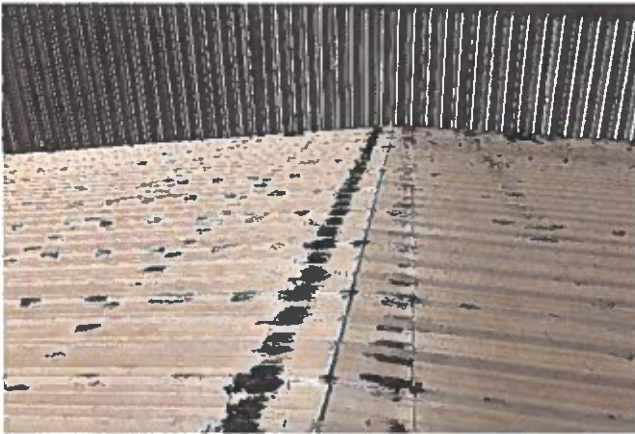
Photograph 9: Office Roof - Middle and right slope at overlap seam; R-panel type metal Office roofing panels

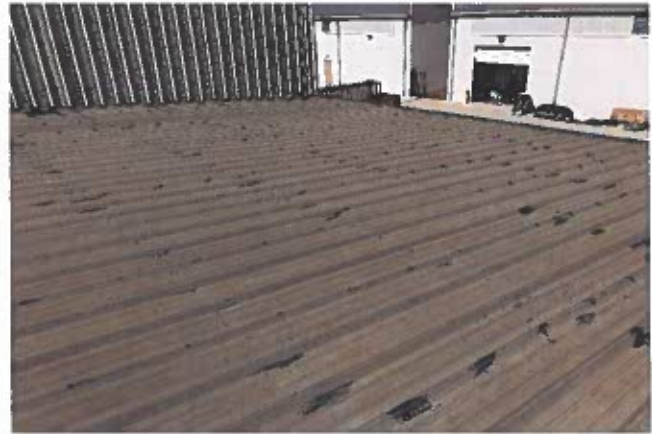
Photograph 10: Office Roof - Right slope; overall view

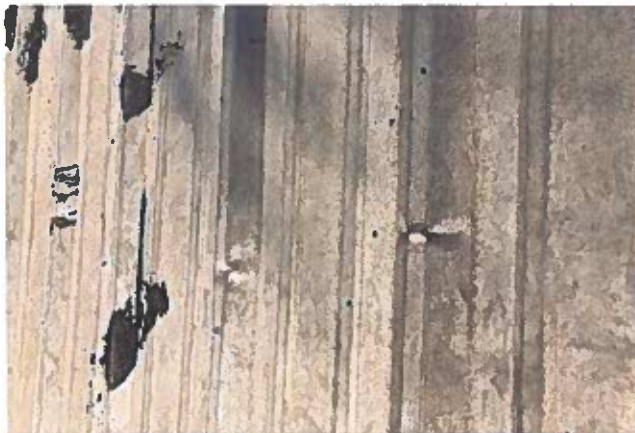
Photograph 11: Office Roof - Crimps on Office Roof; foot traffic

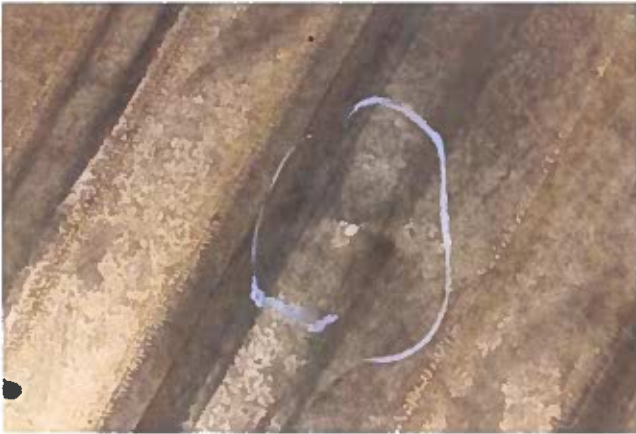
Photograph 13: Office Roof - Crimps on Office roof; foot traffic

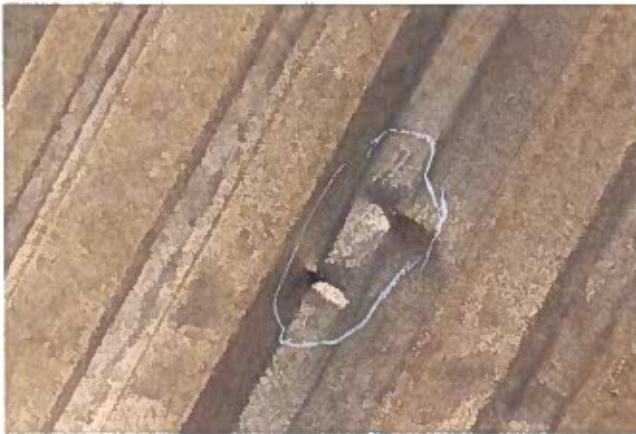
Photograph 15: Office Roof - Crimps on Office roof; foot traffic

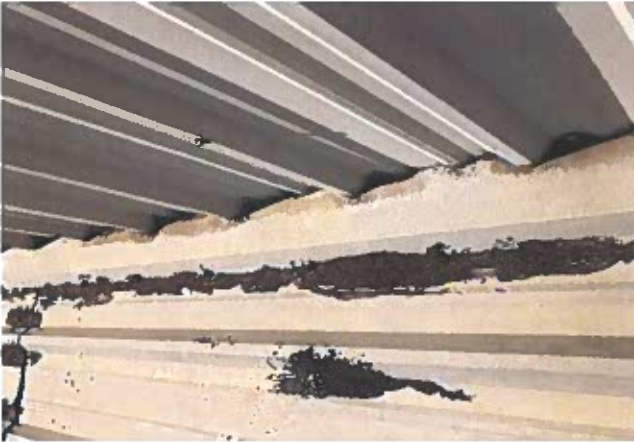
Photograph 19: Office Roof - Sealant applied to flashing at rear building wall

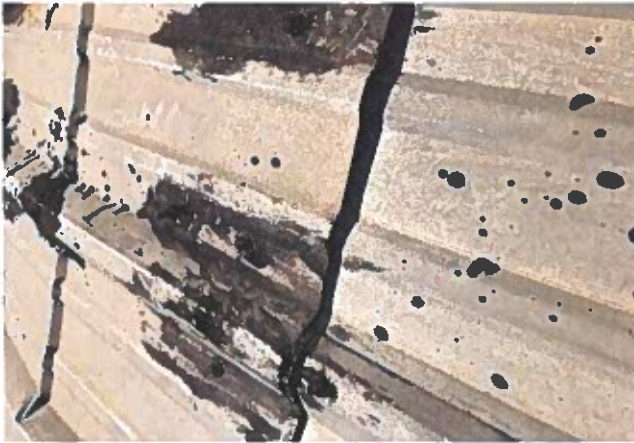
Photograph 21: Office Roof - Wind separated Office roof joint

In our opinion, wind during Hurricane Harvey had sufficient force to cause the observed damage at the Cole & Ashcroft, LP building. As a result of wind damage during Hurricane Harvey, the metal roofs of the office and warehouse, and gutters of the Cole & Ashford, LP building, require removal and replacement.

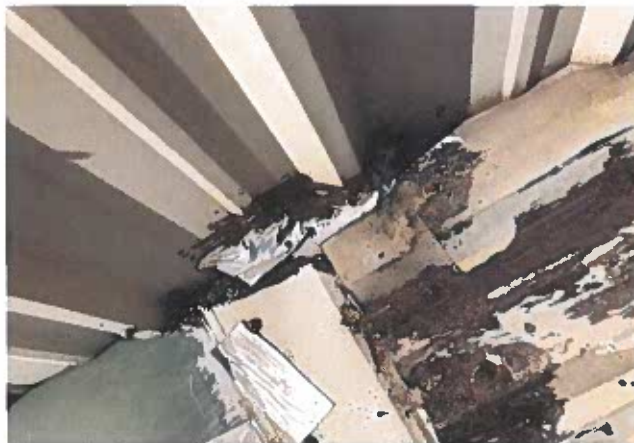
Photograph 23: Office Roof - Sealant applied to flashing at rear building wall

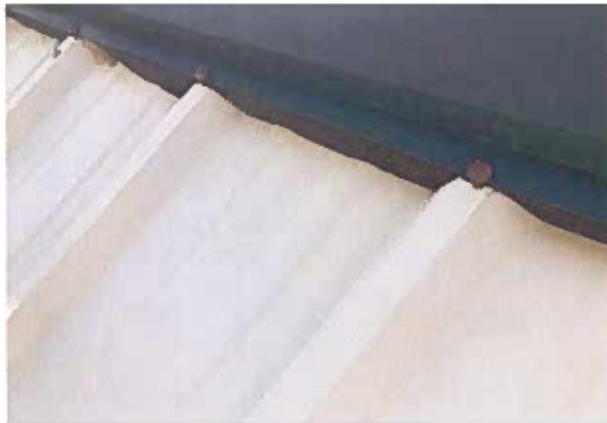
Photograph 27: Office Roof - Remaining closure strips

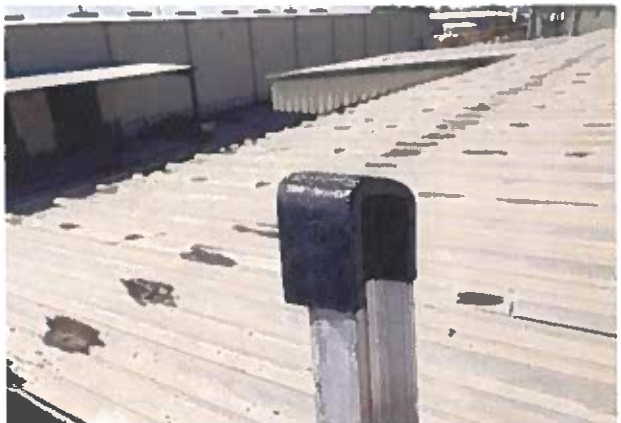
Photograph 28: Warehouse Roof - Overall view of trapezoidal seam metal roof (R-panel); screws have been covered with sealant

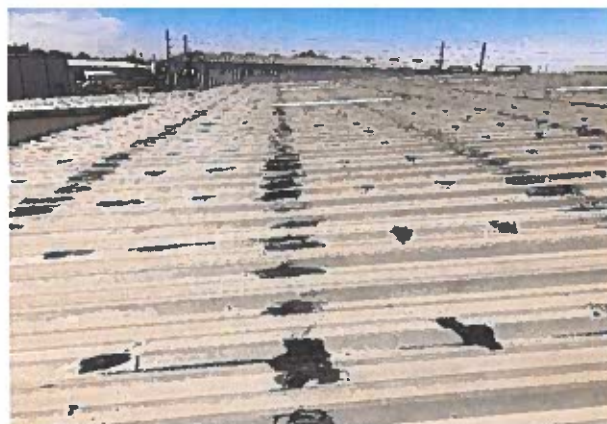
Photograph 29: Warehouse Roof - Overall view of trapezoidal seam metal roof (R-panel); screws have been covered with sealant

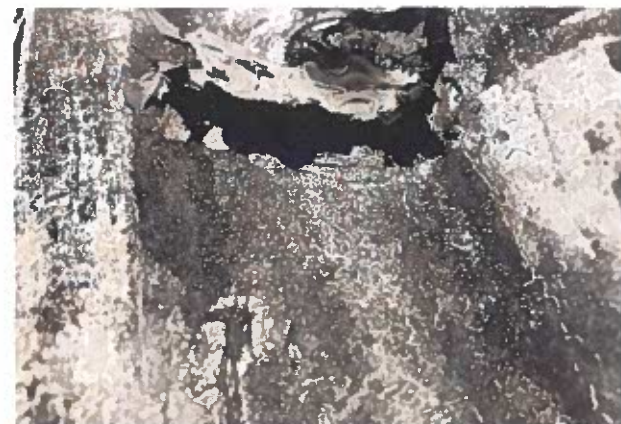
Photograph 30: Warehouse Roof - Sealant applied to screws

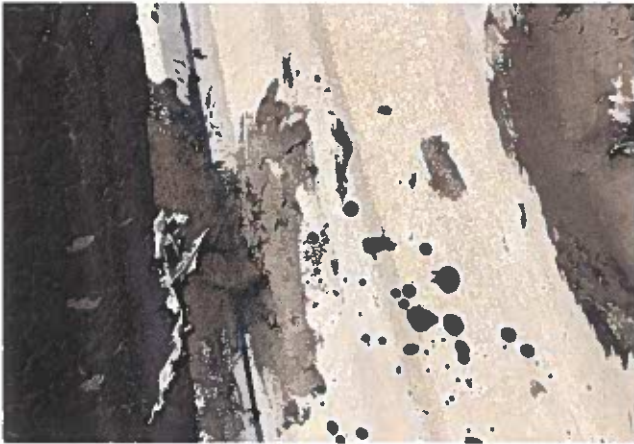
Photograph 31: Warehouse Roof - Sealant on panel standing seam

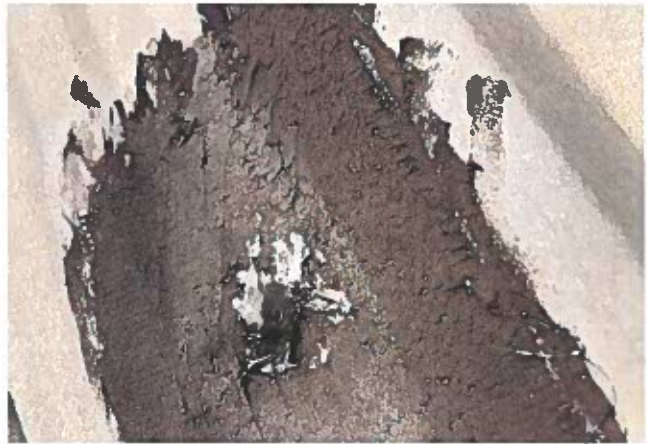
Photograph 32: Warehouse Roof - Sealant applied to screws

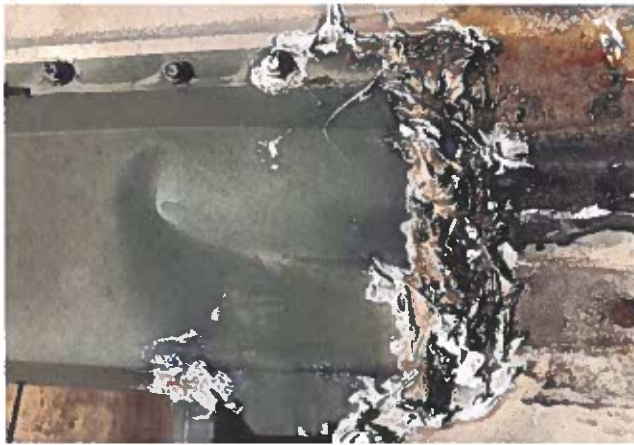
Photograph 33: Warehouse Roof - Sealant applied at edge trim and section strap

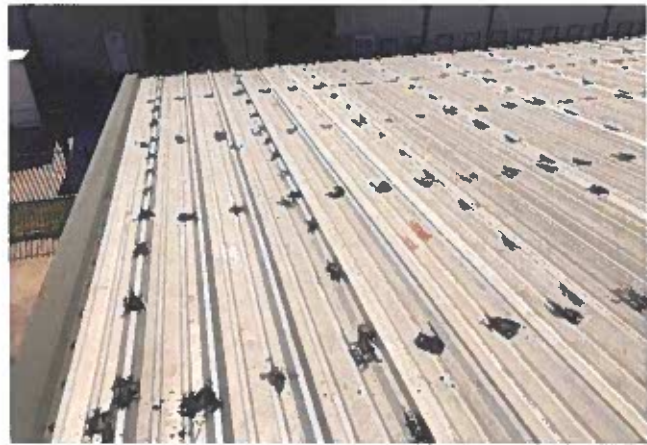
Photograph 34: Warehouse Roof - Edge of roof at front

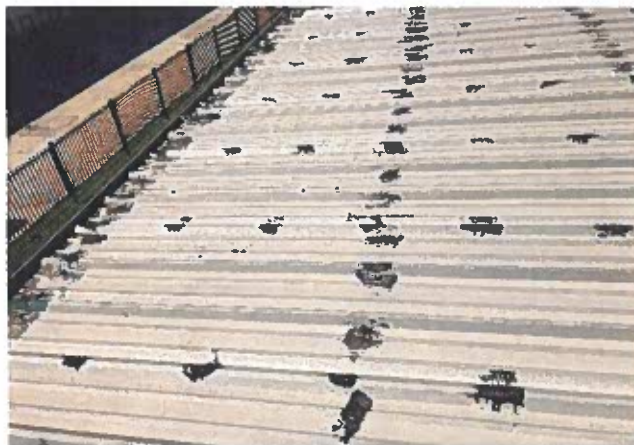
Photograph 35: Warehouse Roof - Overall view along left side

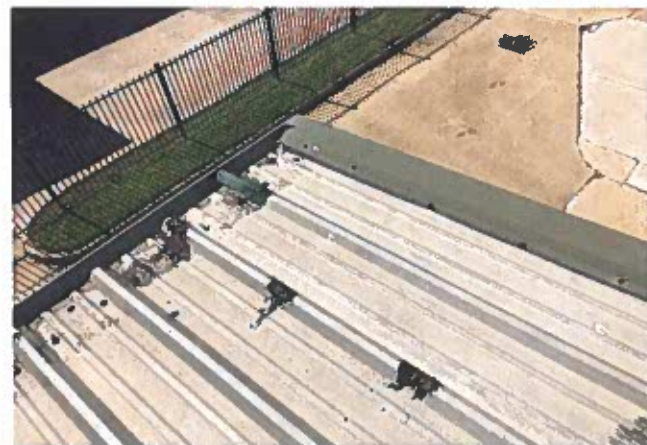
Photograph 36: Warehouse Roof - Roof at rear corner; temporary gutter bracket

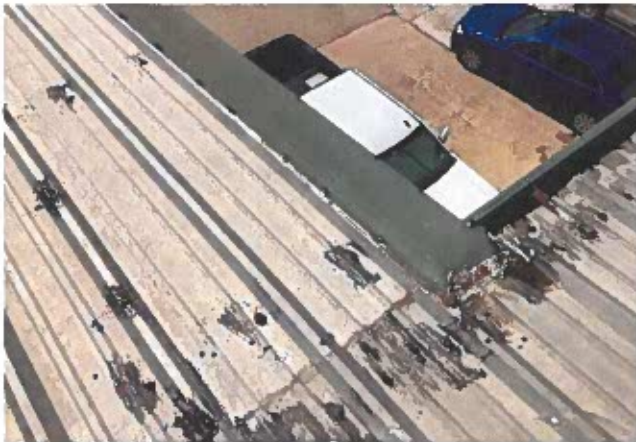
Photograph 37: Warehouse Roof - Roof crimps

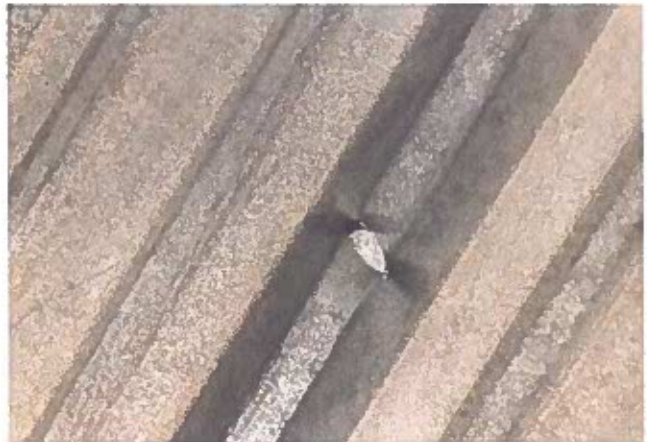
Photograph 38: Warehouse Roof - Mechanical dent on roof panel

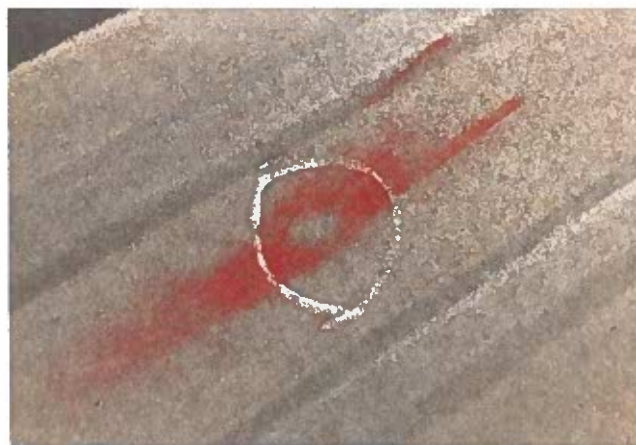
Photograph 41: Warehouse Roof - Hail dent on panel

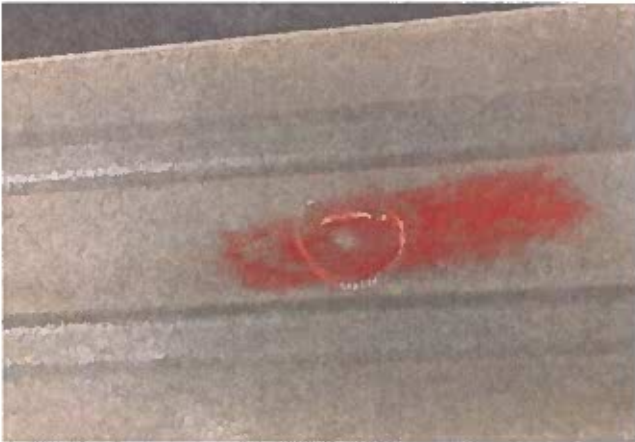
Photograph 43: Warehouse Roof - Hail dent on panel

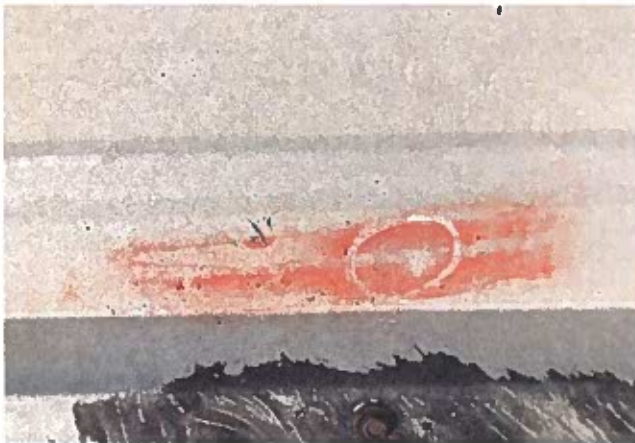
Photograph 45: Warehouse Roof - Hail dent on panel

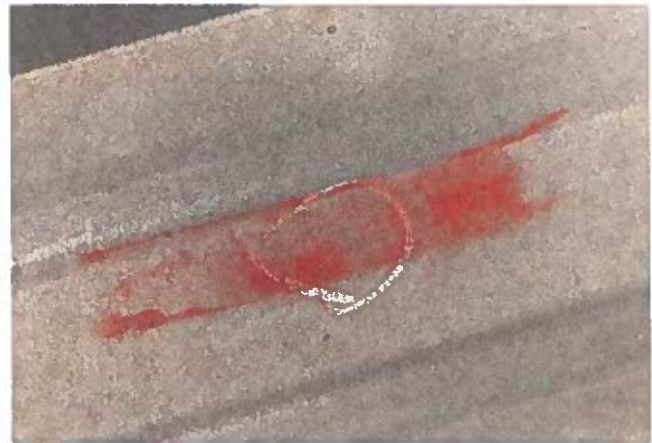
Photograph 46: Warehouse Roof - Hail dent on panel

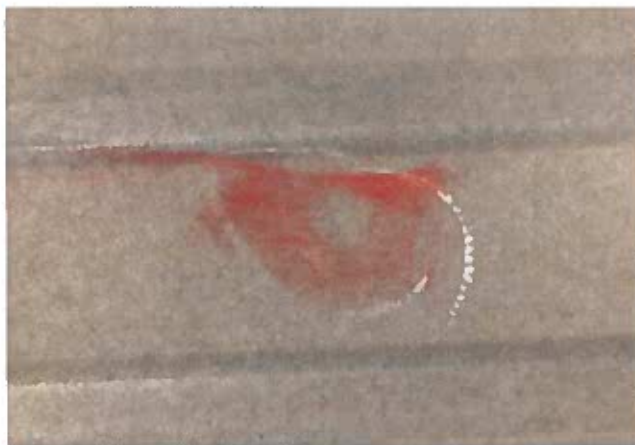
Photograph 47: Warehouse Roof - Hail dent on panel

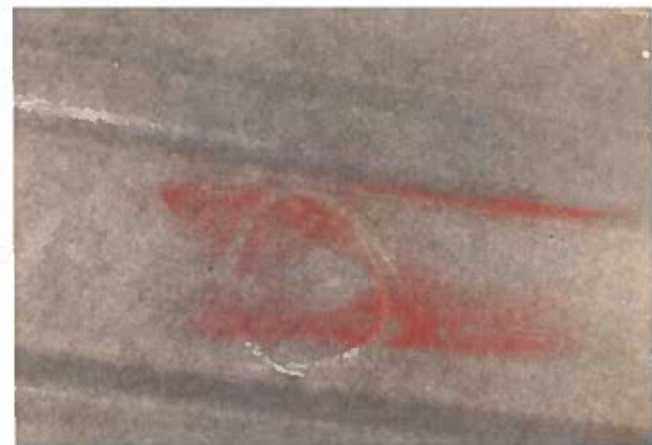
Photograph 48: Warehouse Roof - Hail dent on panel

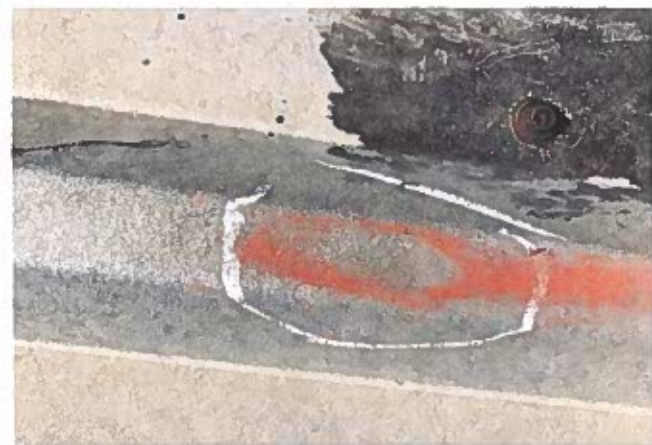
Photograph 54: Warehouse Roof - Hail dent on roof panel

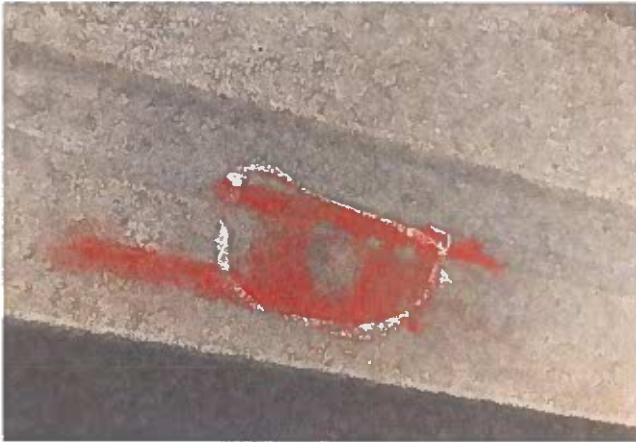
Photograph 55: Warehouse Roof - Hail dent on roof panel

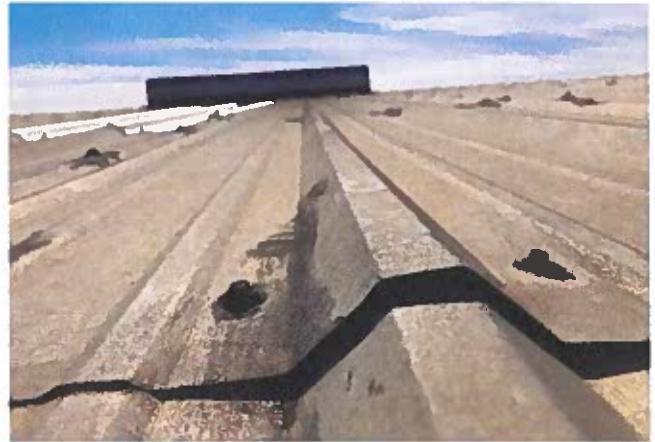
Photograph 62: Warehouse Roof - Wind separated overlap joint

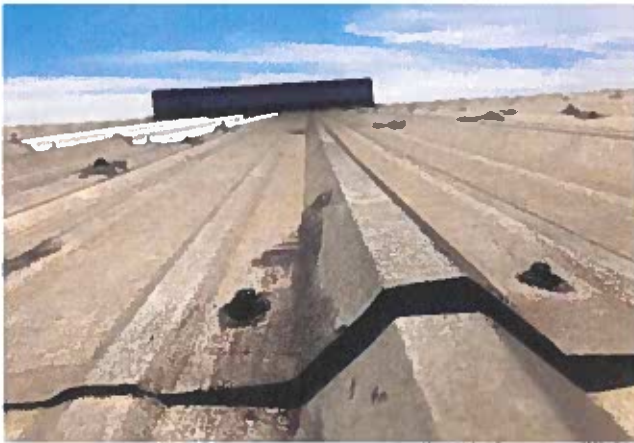
Photograph 63: Warehouse Roof - Wind separated overlap joint

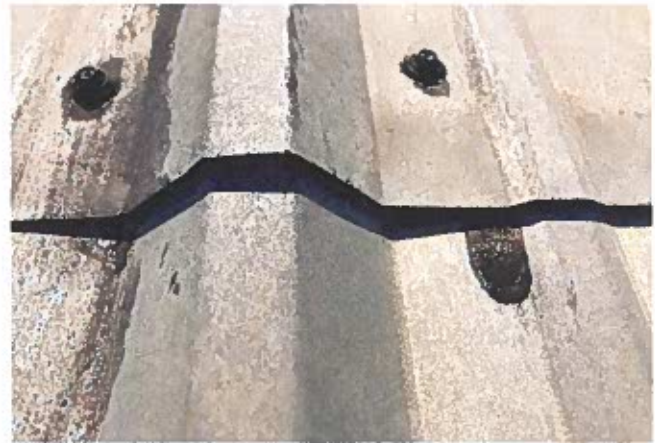
Photograph 64: Warehouse Roof - Wind separated overlap joint; dent on roof panel at screw

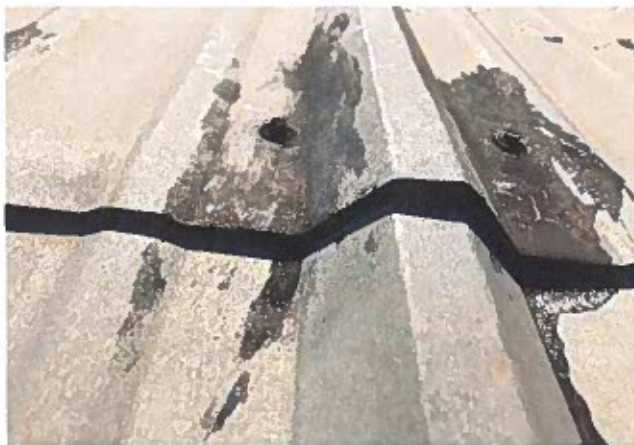
Photograph 65

Photograph 65: Warehouse Roof - Wind separated overlap joint

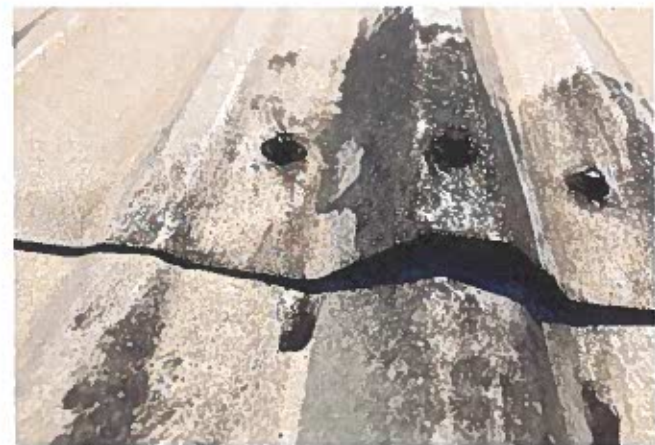
Photograph 66: Warehouse Roof - Wind separated overlap joint; panel dent at screw

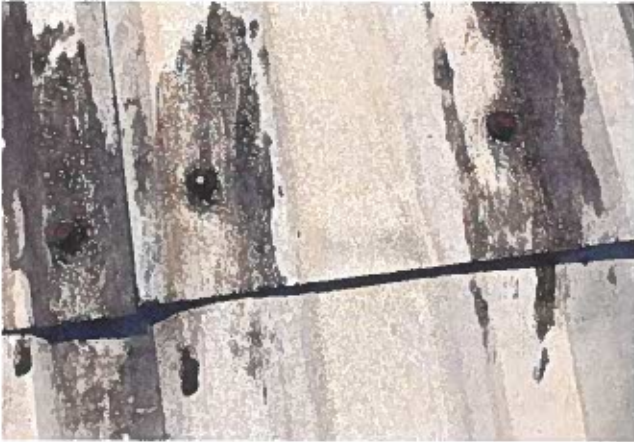
Photograph 67: Warehouse Roof - Wind separated overlap joint

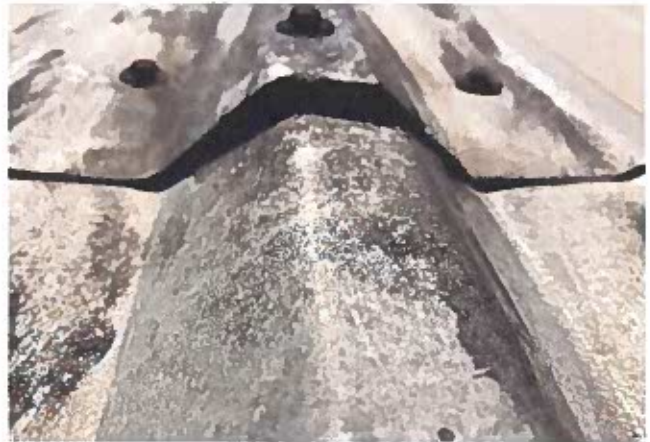
Photograph 68

Photograph 68: Warehouse Roof - Wind separated overlap joint

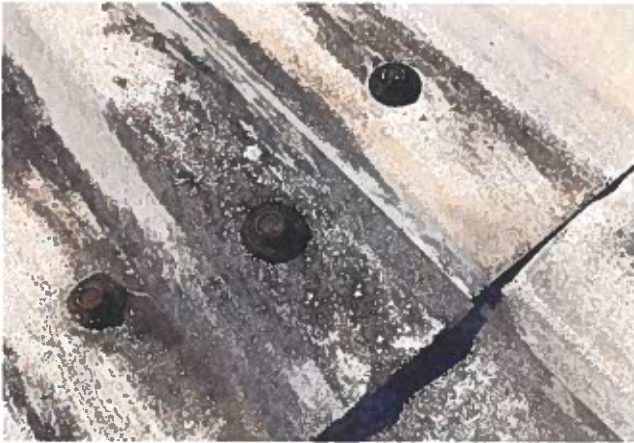
Photograph 69: Warehouse Roof - Wind separated overlap joint; panel dent at screw

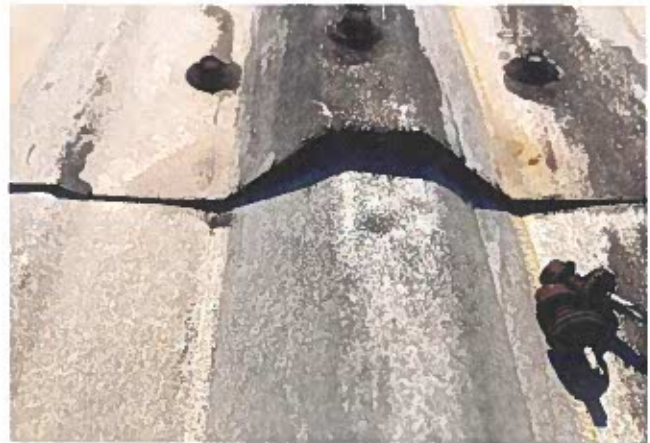
Photograph 70: Warehouse Roof - Wind separated overlap joint

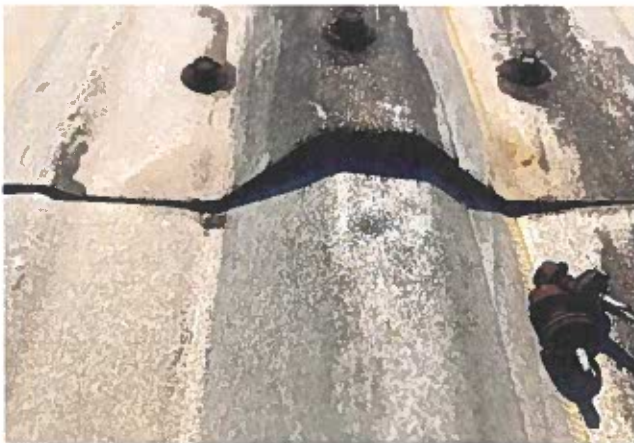
Photograph 71: Warehouse Roof - Wind separated overlap joint

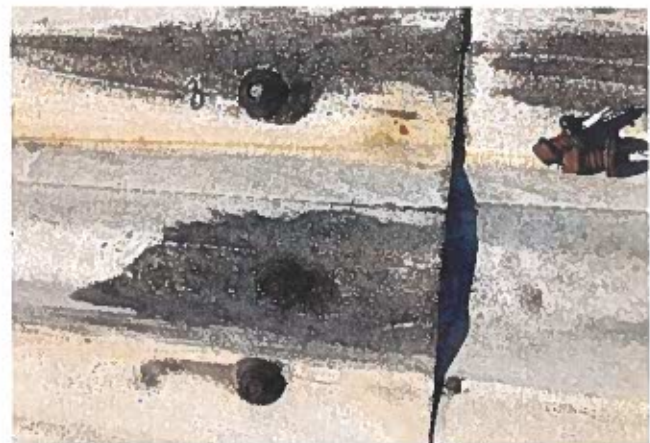
Photograph 72: Warehouse Roof - Wind separated overlap joint

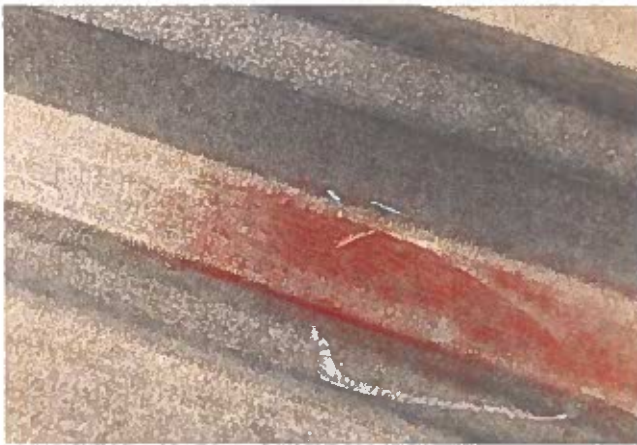
Photograph 81: Warehouse Roof - Hail dent on roof panel

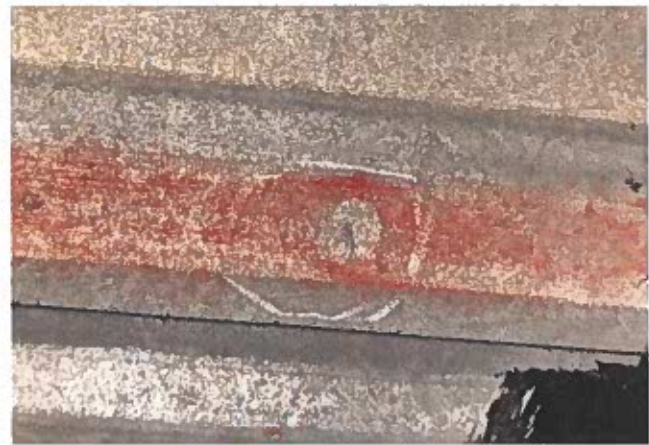
Photograph 82: Warehouse Roof - Hail dent on roof panel

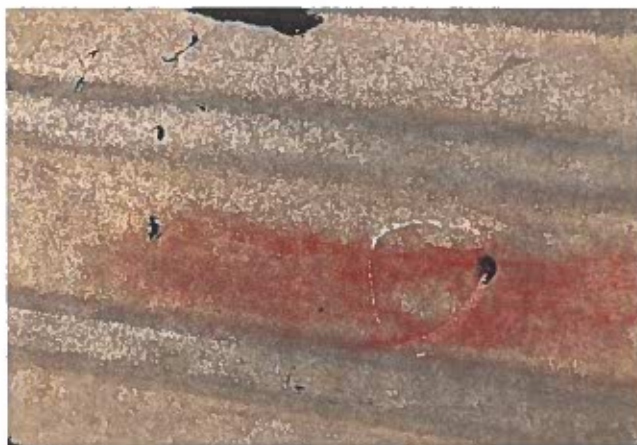
Photograph 83: Warehouse Roof - Hail dent on roof panel
